Manhole Inspection Summary

Manhole # S27E__003MH

Insp Date: **8/10/09 1:39 PM**

Location Address: **762 LEXINGTON ST**

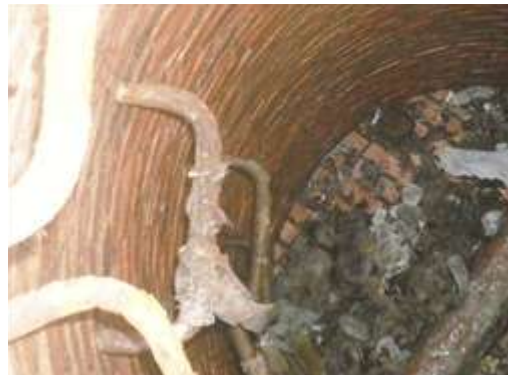
Defect 2

Surcharge ☒ **Evidence Of Surcharge** Depth: **8** (ft.) ☐ Active Surcharge Present

EVIDENCE OF SURCHARGE ON STEP

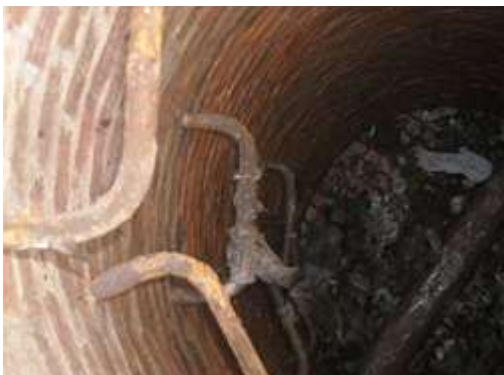
Defect 1

Steps Count: **8** Missing: **0** ☒ **Corroded**

DEBRIS ON BENCH, CORRODED STEPS

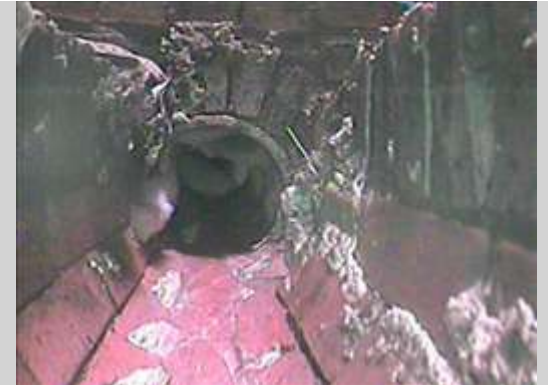
12 O'Clock Outflow

8 in. Circular Gravity Sewer
Pipe Out @ 12 O'Clock

Pipe Height: **8.4** (in.) Rod and Bar (Angled)
Pipe Material: **Clay** ☐ Pipe Lined
Invert Depth: **15.55** (ft.) Flow Characteristics: **Slow**
Deposits: ☐ None ☐ Mud ☒ **Sludge** ☐ Debris ☐ Grease
Silt Depth: **4** (in.) Deposits Extent: **Heavy**
Infiltration: **None** Pipe Seal Cond: **Sound**

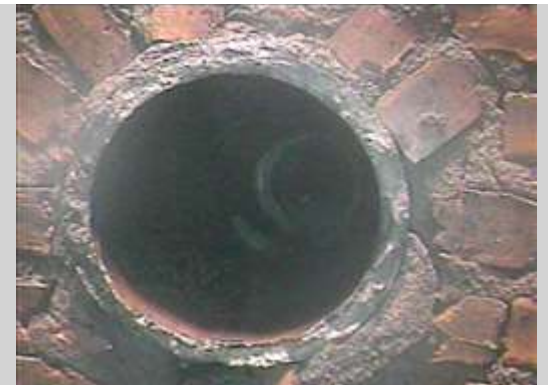
6 O'Clock Inflow

8 in. Circular Gravity Sewer
Pipe In @ 6 O'Clock

Pipe Height: **8.4** (in.) Rod and Bar (Angled)
Pipe Material: **Clay** ☐ Pipe Lined
Invert Depth: **10.46** (ft.) Flow Characteristics: **Fast**
Deposits: ☒ None ☐ Mud ☐ Sludge ☐ Debris ☐ Grease
Silt Depth: (in.) Deposits Extent:
Infiltration: **None** Pipe Seal Cond: **Sound**

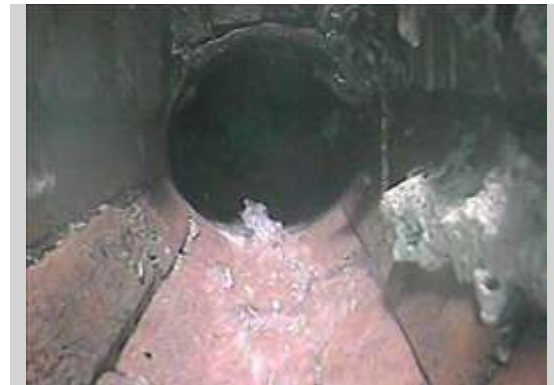
Drop In @ 6 O'Clock

Drop: **Outside** Rod and Bar
Angled: **Yes** Reading: **14.27** (ft.)
Inv Depth: **15.27** (ft.)

Drop Condition: **Open**
